**BIG LAKE DAM
JEFFERSON COUNTY, MISSOURI
MO. 30457**

**PHASE I INSPECTION REPORT
NATIONAL DAM SAFETY PROGRAM**

JULY 1981

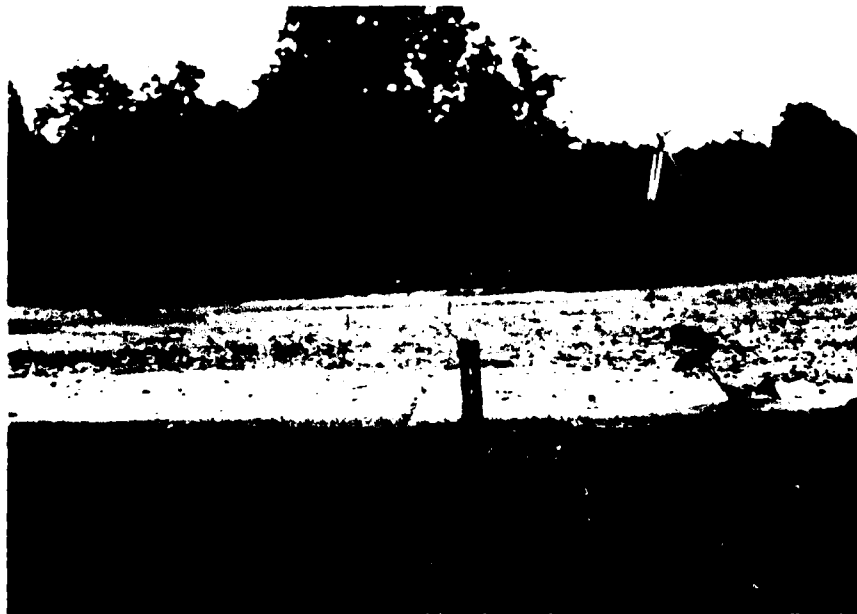
There are several top to bottom cracks in the concrete wall of the spillway inlet with separation and displacement of 1/4 to 1/2 inch (see Photo 6). The cracks are due probably to differential settlement of the wall. The surface of the concrete appears sound with no excessive weathering evident. The gravel surfacing of the broad-crested weir is generally smooth and uniform with the exception of one minor depression due probably to vehicular traffic (see Photo 5). The bottom of the discharge channel immediately downstream of the spillway weir is a composite of bare earth marked with erosional rivulets and pieces of concrete (see Photo 7). As the channel begins to bend towards the downstream channel, a mass of dumped debris covers the start of the heavily eroded V-shaped cross section, which has steep bare earth side slopes (see Photo 8). The sides slopes are unprotected as the channel descends toward the downstream channel (see Photo 9). A second mass of dumped debris was observed in the discharge channel at about halfway down the channel.

1. The cracks in the inlet wall of the spillway do not appear to be a hazard to the stability of the spillway at the present time. Nonetheless, as the displacement along the cracks increases with time, the spillway, due to its weakened condition, will be more susceptible to damage from future flows.

Photo 6 - Close-up view of a crack in the concrete wall inlet of the spillway.

2. The cracking and displacement of the concrete of the spillway control section should be closely monitored and repairs made when deemed necessary by a qualified professional engineer.
